EXPERIMENTAL INVESTIGATION OF AIR-COOLED TURBINE BLADES  
IN TURBOJET ENGINE

IX - EVALUATION OF THE DURABILITY OF NONCRITICAL ROTOR  
BLADES IN ENGINE OPERATION

By Francis S. Stepka and Robert O. Hickel

December 5, 1951  
Declassified December 11, 1953

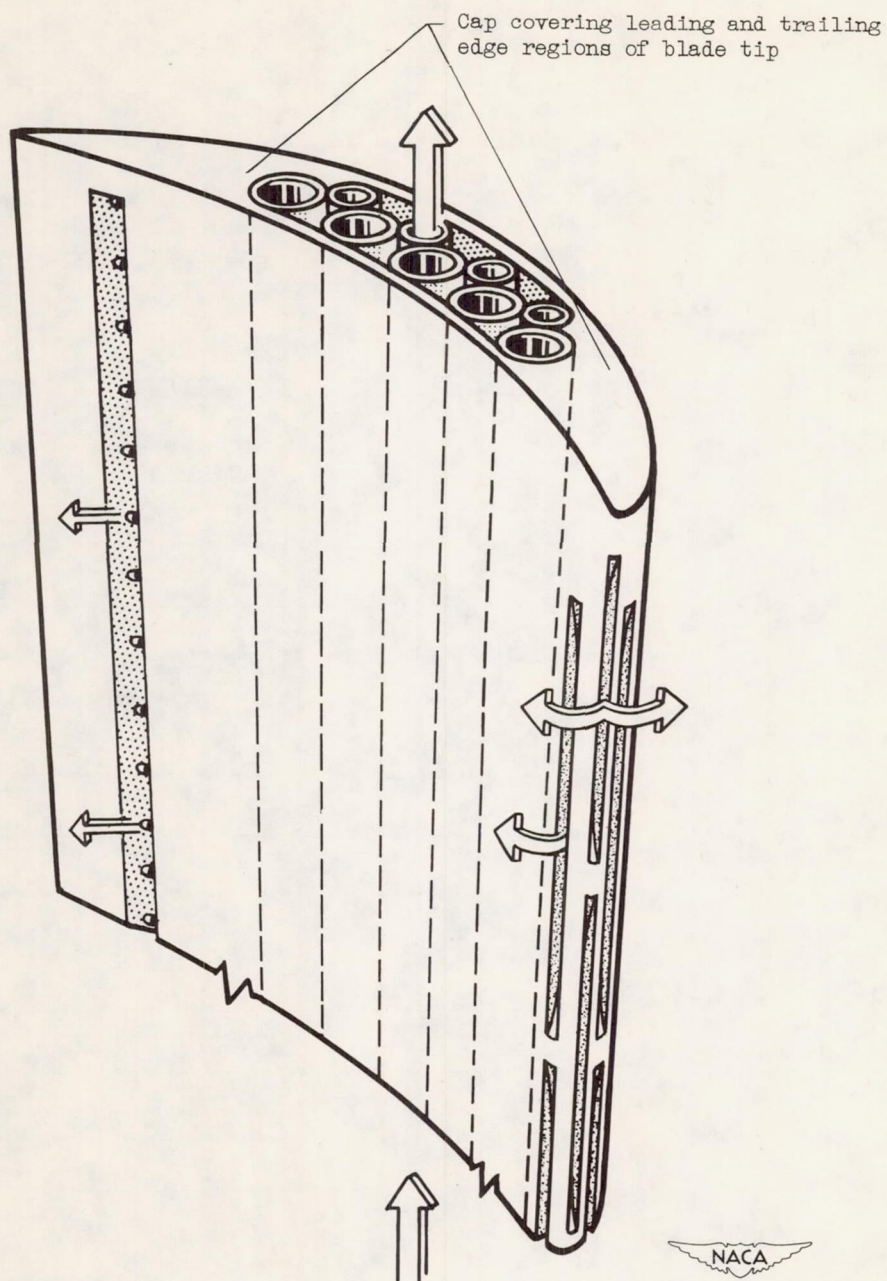
Figure 1. - Air-cooled blade, configuration A. (Arrows indicate cooling-air flow.)

Configuration A. - The first configuration (A) investigated had special film-cooled leading and trailing edges as shown in figure 1. The film cooling augmented the forced-convection cooling obtained with air-cooled blades such as those described in references 1 to 3. The leading edge was film cooled by passing air through three rows of radial slots (fig. 1). The leading-edge row consisted of four slots and the rows on either side of the leading edge had three slots each. These slots were 0.010 inch wide and about  $7/8$  inch long. Configuration A had a "sharp" leading edge, its radius being 0.05 inch. The trailing edge was film cooled by air passing through 29 holes of 0.040-inch diameter spaced 0.125 inch apart in a radial groove that was cut in the pressure surface of the blade 0.375 inch from the trailing edge. The tips of the blades were capped at the leading- and trailing-edge sections forcing a portion of the cooling air to flow through the slots and holes in the leading and trailing edges. The interior of the blade was packed with nine SAE 1020 steel tubes to increase the heat-transfer surface area in the midchord section. The tubes were Nicro-brazed in place. The leading-edge modification of configuration A was similar to that of blades 7 and 8 in reference 4, whereas the trailing-edge modification was similar to that of blade 6 in reference 4. Two blades (A1 and A2) of this configuration were cast of a noncritical material, SAE 4130 steel, and 2 blades (A3 and A4) were cast from a high temperature alloy, AMS 5382A. These blades were investigated as cast (no heat-treatment).

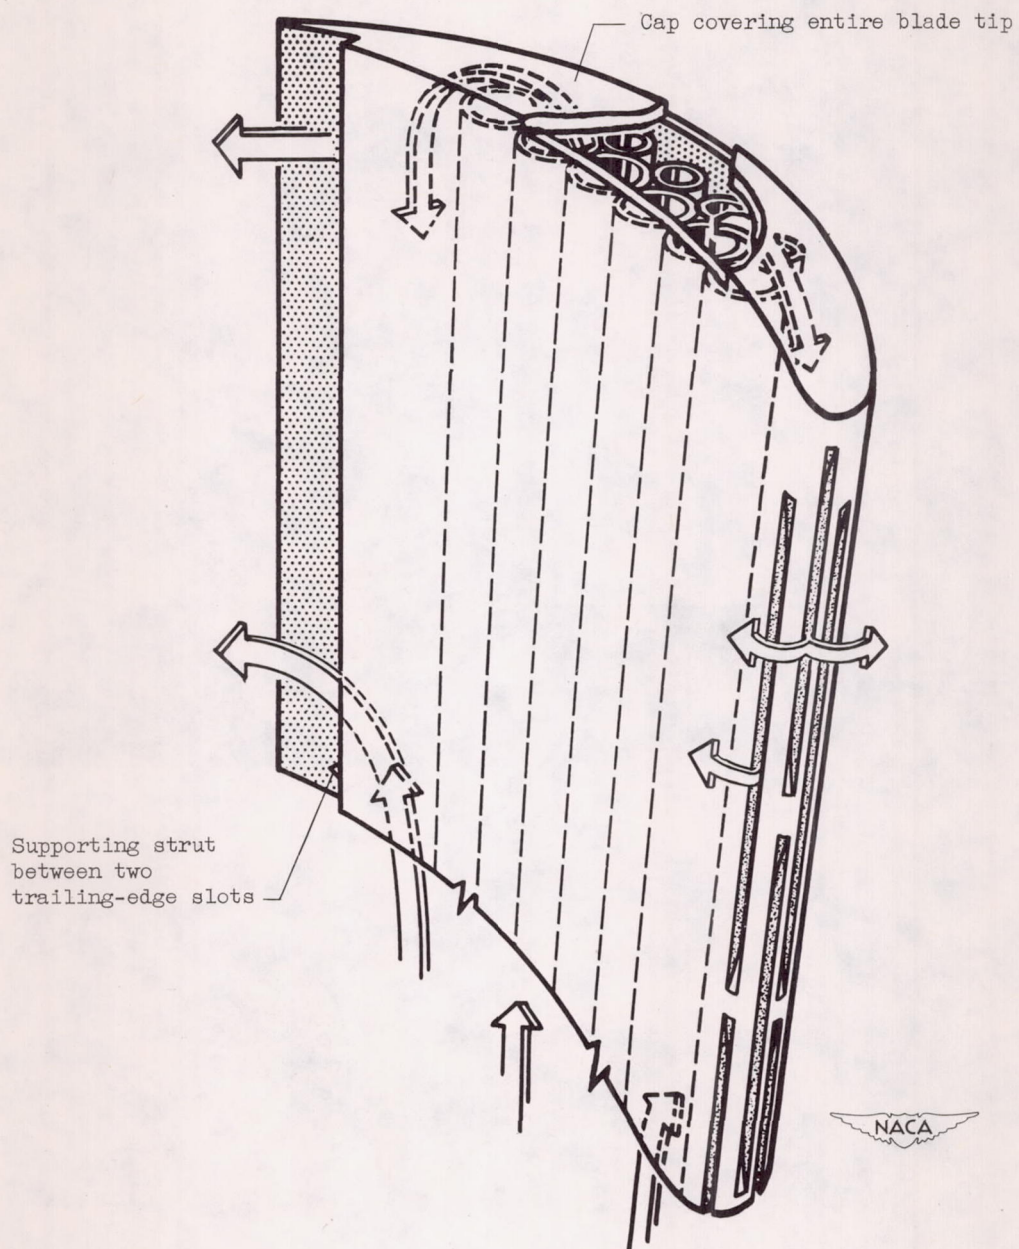
Figure 2. - Air-cooled blade, configuration B. (Arrows indicate cooling-air flow.)

Configuration B. - Configuration B (fig. 2) was designed as a double flow blade in order to make use of natural-convection effects that would augment the forced convection and film cooling of configuration A. Configuration B was similar to blade 14 of reference 6, in which the cooling effectiveness of several double-flow blades is presented. The shells and bases of configuration B were integrally cast of SAE 4130 steel. Ten SAE 1020 steel tubes were Microbrazed in the midchord section of the blade so that they terminated approximately  $1/4$  inch from the tip of the blade, which was entirely capped (fig. 2).

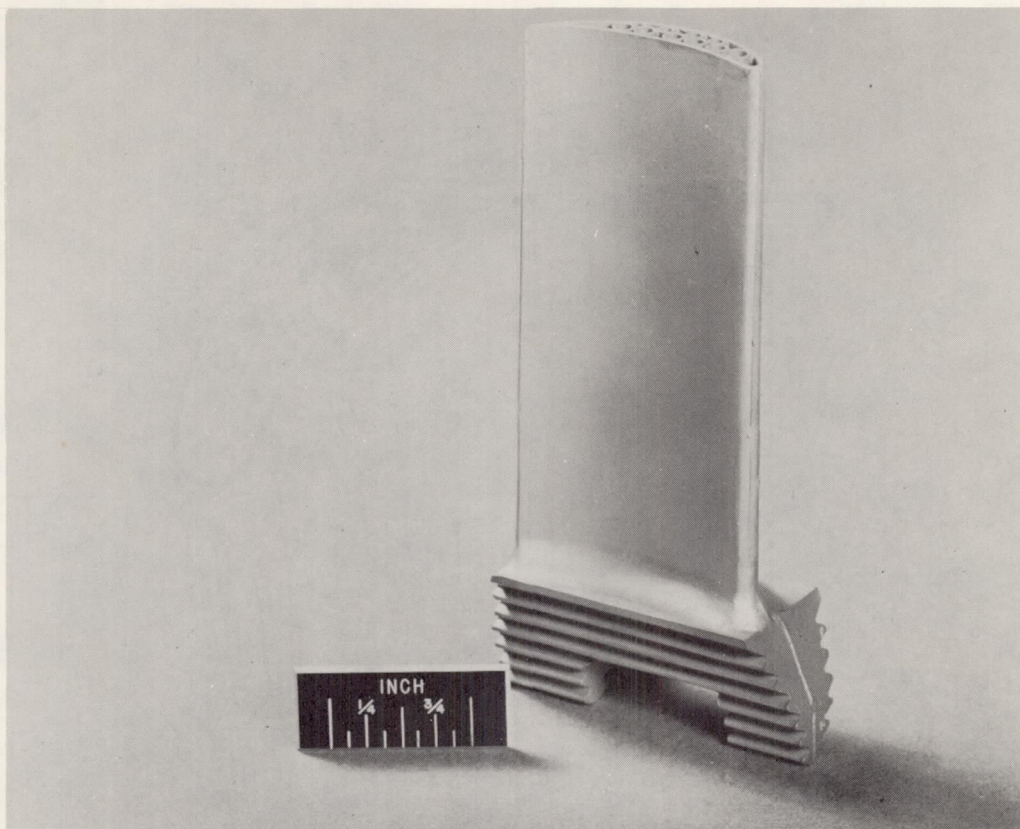
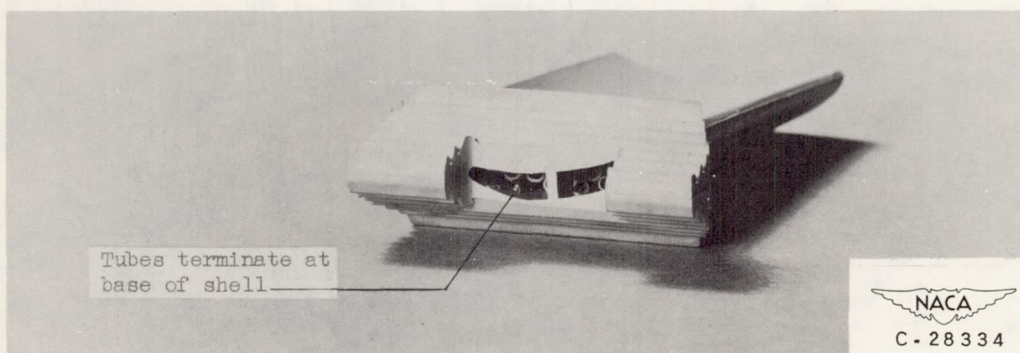
Figure 3. - Air-cooled blade, configuration C.

Configuration C. - The third configuration (C) investigated had the bases and shells integrally cast of SAE 4130 steel. This configuration (fig. 3) had nine steel tubes inserted and Microbrazed in the midchord region of the shell. No special method for cooling the leading- and trailing-edge regions was used. This configuration was similar to that reported in reference 1, in which the cooling effectiveness of this type of configuration is presented. Two blades (C1 and C2) of this configuration were fabricated and investigated in the as-cast condition.

Configuration C. - One blade of configuration C (fig. 3) cast of SAE 4130 steel with no heat-treatment was installed in the turbine rotor for the endurance test. This blade was operated for 1 hour at both 11,000 and 11,500 rpm at a cooling-air to combustion-gas flow ratio per blade of 0.15. At the end of this time, the second and third tube inserts from the trailing edge, which were not completely in contact with the shell at the beginning of test, parted from the shell near the tip; nevertheless, the test was continued for a total time of 8 hours (4 hr at rated speed) when the second tube from the trailing edge broke approximately  $1\frac{1}{4}$  inch from the base and damaged the tip of the blade as it came out of the cooling-air passage. An attempt to repair this blade was unsuccessful and it was removed from the rotor and replaced by a similar blade. Although a radiograph inspection of this second blade prior to installation revealed shrinkage and porosity above a third span length from the base, the blade was used in order to determine whether these defects had a serious effect on structural strength of the blade. After a total running time of approximately 31 hours (22 hr at rated speed) the test of this blade was terminated because of distortion and excessive creep at the trailing edge. The distortion of this blade after 2 minutes of the eighty-first cycle of operation as compared with a blade that had not been endurance tested is shown in figure 5. Small cracks at the leading edge, which are apparently hot tears, were also observed at the termination of the test. This excessive creep may have resulted because the blade was not heat-treated. Also the elongation may have been caused by malfunctioning of one of the engine components which occurred during the first 2 minutes of the eighty-first cycle and caused the effective gas temperature to reach a value of  $1570^{\circ}\text{F}$ , which is  $120^{\circ}\text{F}$  higher than that normally maintained for the endurance investigations. The engine was shut down immediately and the elongation of the turbine blades was observed.

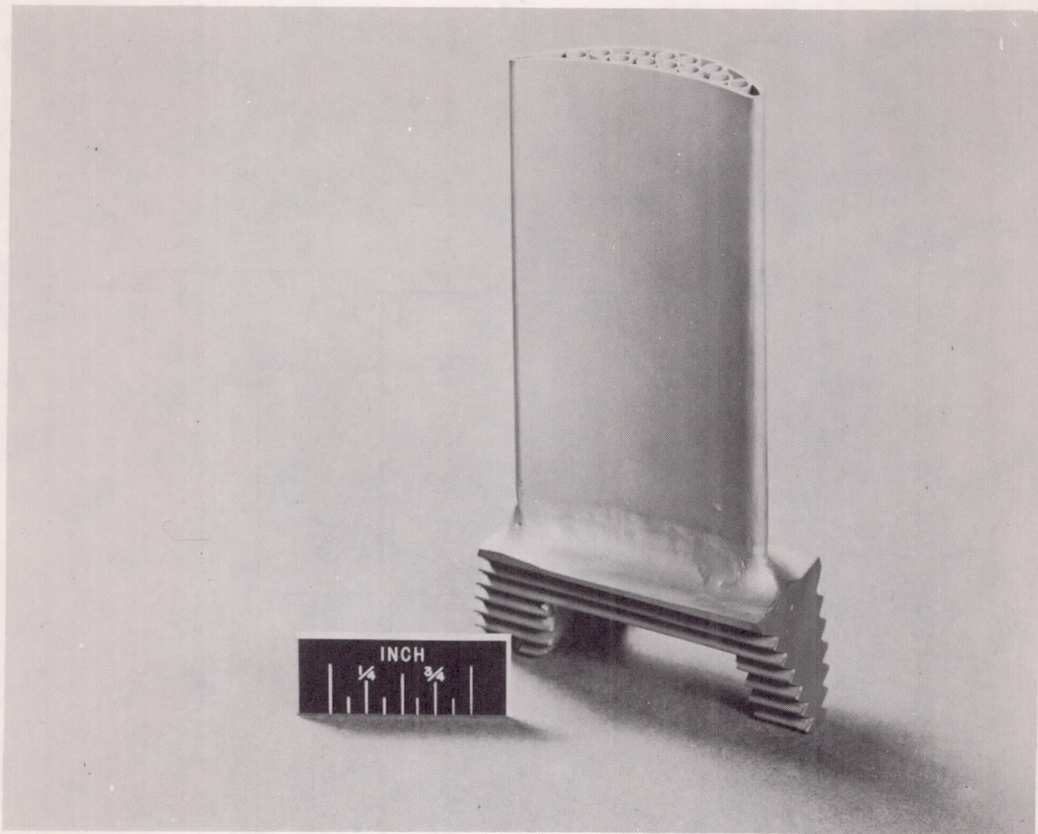
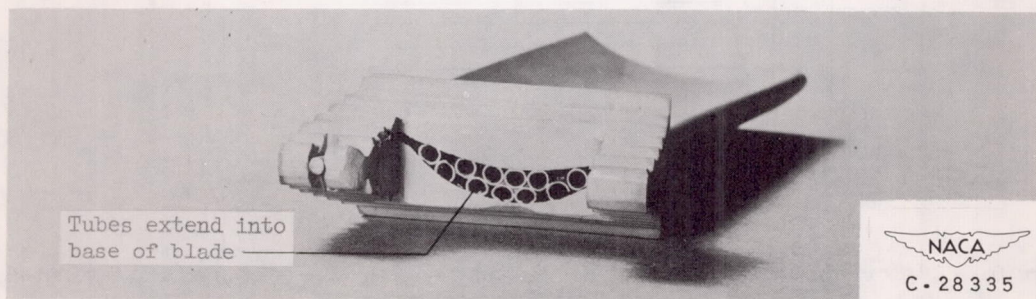
Figure 4. - Air-cooled blade, configuration E.

Configuration E. - Configuration E was fabricated from a formed shell having the same profile as configuration D. The formed shell was arc butt welded to a protruding lip on the cast base. (For details of this fabrication method, see reference 12.) This method was probably a more desirable method of attaching the shell to the base than the fillet weld employed in fabricating configuration D. Configuration E (fig. 4) had 12 steel tubes brazed in the midchord region. In all the previous configurations, the tubes terminated at the base of the shell as shown in figure 3 and the shell supported the entire weight of the tubes. In configuration E, however, the tubes were extended about 0.4 inch into the blade base and were brazed to the base. In this manner the tubes tend to support some of their own weight and thus the shell stresses are reduced (reference 1). A total of four blades (E1, E2, E3, and E4) of this configuration were fabricated. In order to investigate the endurance characteristics of another noncritical material and to compare the results with SAE 4130 steel, two of the blades (E3 and E4) were fabricated of Timken 17-22A(S) alloy and two (E1 and E2) of SAE 4130 steel. One blade of each of these materials had the tubes in the midchord section Nicrobrazed in place; two had the tubes copper brazed in place.

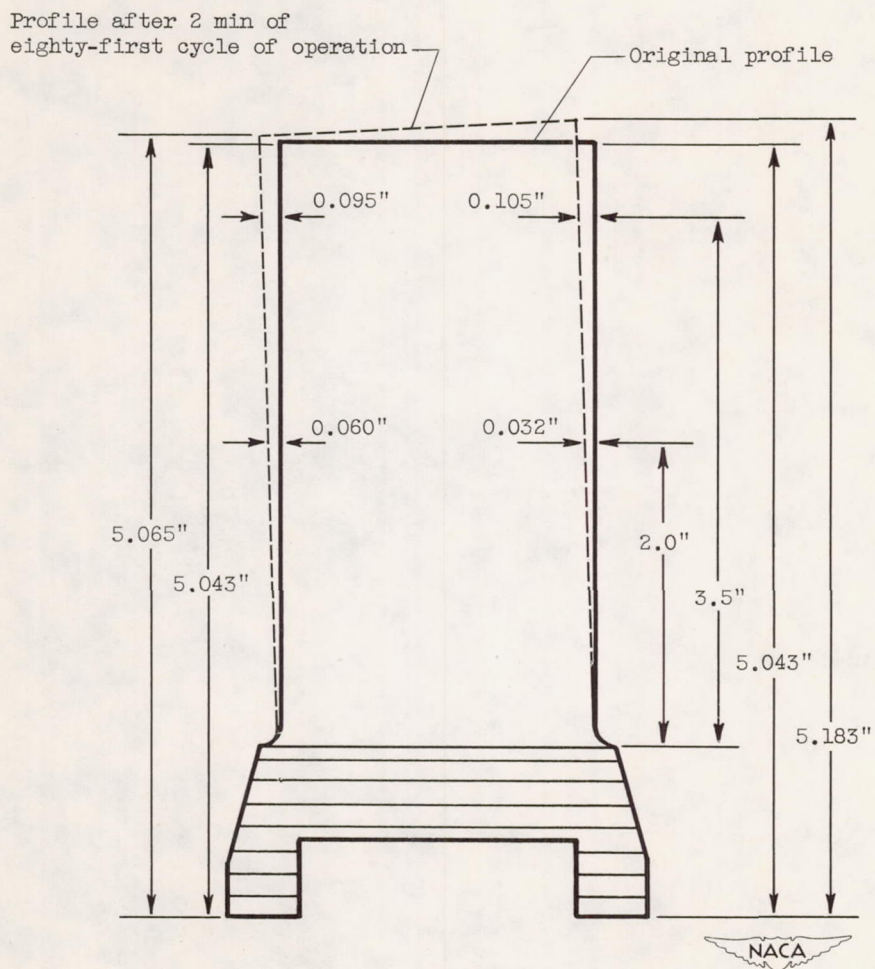
Figure 5. - Distortion and creep of blade C2 (cast of SAE 4130 steel) after 2 minutes of eighty-first cycle of operation.

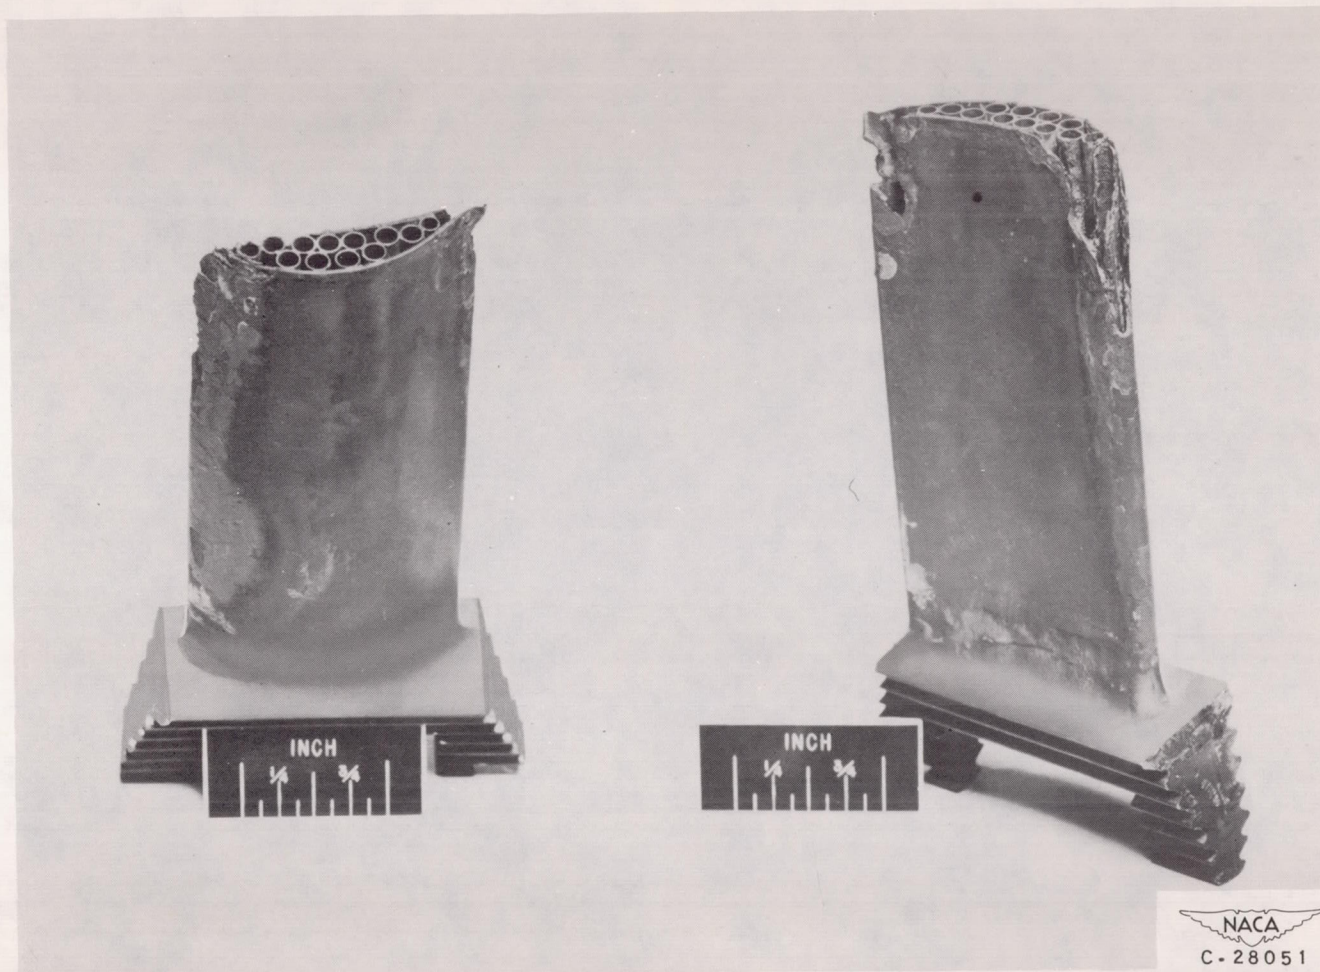
| Blade configuration | Blade | Blade material | Nominal engine speed (rpm) | Time at speed | | Ratio of coolant to gas flow | Effective gas temperature (°F) | Remarks |
|---|---|---|---|---|---|---|---|---|
| | | | 4,000 | 12 | 50 | --- | --- | Cyclic test. Oxide scale observed after 20 cycles. Blade completed 154 cycles. Excessive oxidation at the tip of the blade. Test on this blade terminated. |

Figure 6. - Condition of blade E2 made of SAE 4130 steel after 154 cycles of operation.
